Norseman Aerodrome

Take-Off and Approach Surveys

Date: 30/11/2021

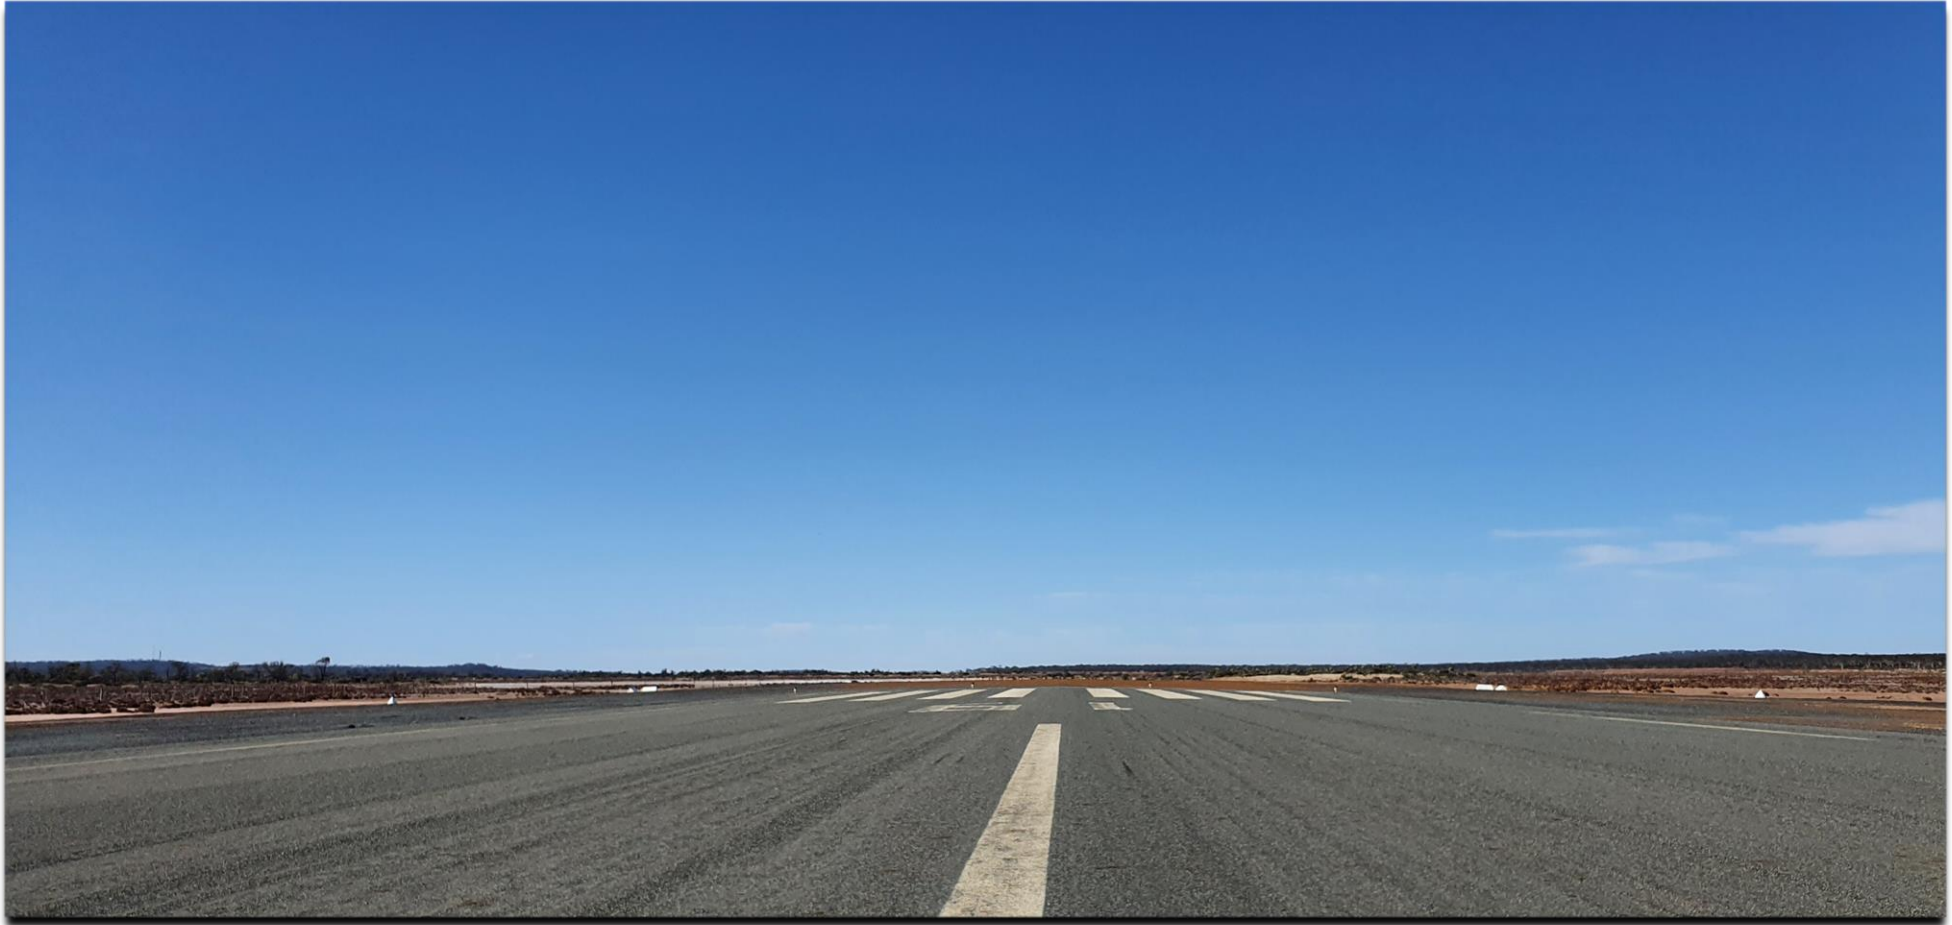
Runway 01 Take-off

1	1	Tree	90.62 m	6.41 m	7.07%	270.05 m	1569.62 m	189.44 mL	Outside TKOF SFC		
1	2	Tree	131.88 m	6.79 m	5.15%	270.43 m	1610.88 m	211.21 mL	Outside TKOF SFC		
1	3	Tree	194.31 m	5.88 m	3.02%	269.52 m	1673.31 m	174.25 mL	Outside TKOF SFC		
1	4	Tower	5655.63 m	126.28 m	2.23%	389.91 m	7134.63 m	3534.04 mL	Outside TKOF SFC		
1	5	Tower	5666.91 m	116.35 m	2.05%	379.99 m	7145.91 m	3515.92 mL	Outside TKOF SFC		
1	6	Tree	1282.05 m	7.64 m	0.59%	271.28 m	2761.05 m	379.36 mL	Outside TKOF SFC		
1	7	Bollard	346.18 m	1.62 m	0.46%	265.26 m	1825.18 m	23.8 mR			
1	8	Tree	345.31 m	2.53 m	0.73%	266.17 m	1824.31 m	57.06 mR			
1	9	Tree	250.54 m	6.56 m	2.62%	270.2 m	1729.54 m	65.65 mR	Critical Object		
1	10	Tree	229 m	3.06 m	1.33%	266.7 m	1708 m	75.07 mR			
1	11	Tree	394.05 m	3.62 m	0.92%	267.26 m	1873.05 m	151 mR	Outside TKOF SFC		
19	1	Tree	76.28 m	12.72 m	16.68%	276.75 m	1555.28 m	177.29 mL	Outside TKOF SFC		
19	2	Tree	146.62 m	10.39 m	7.08%	274.42 m	1625.62 m	148.95 mL	Outside TKOF SFC

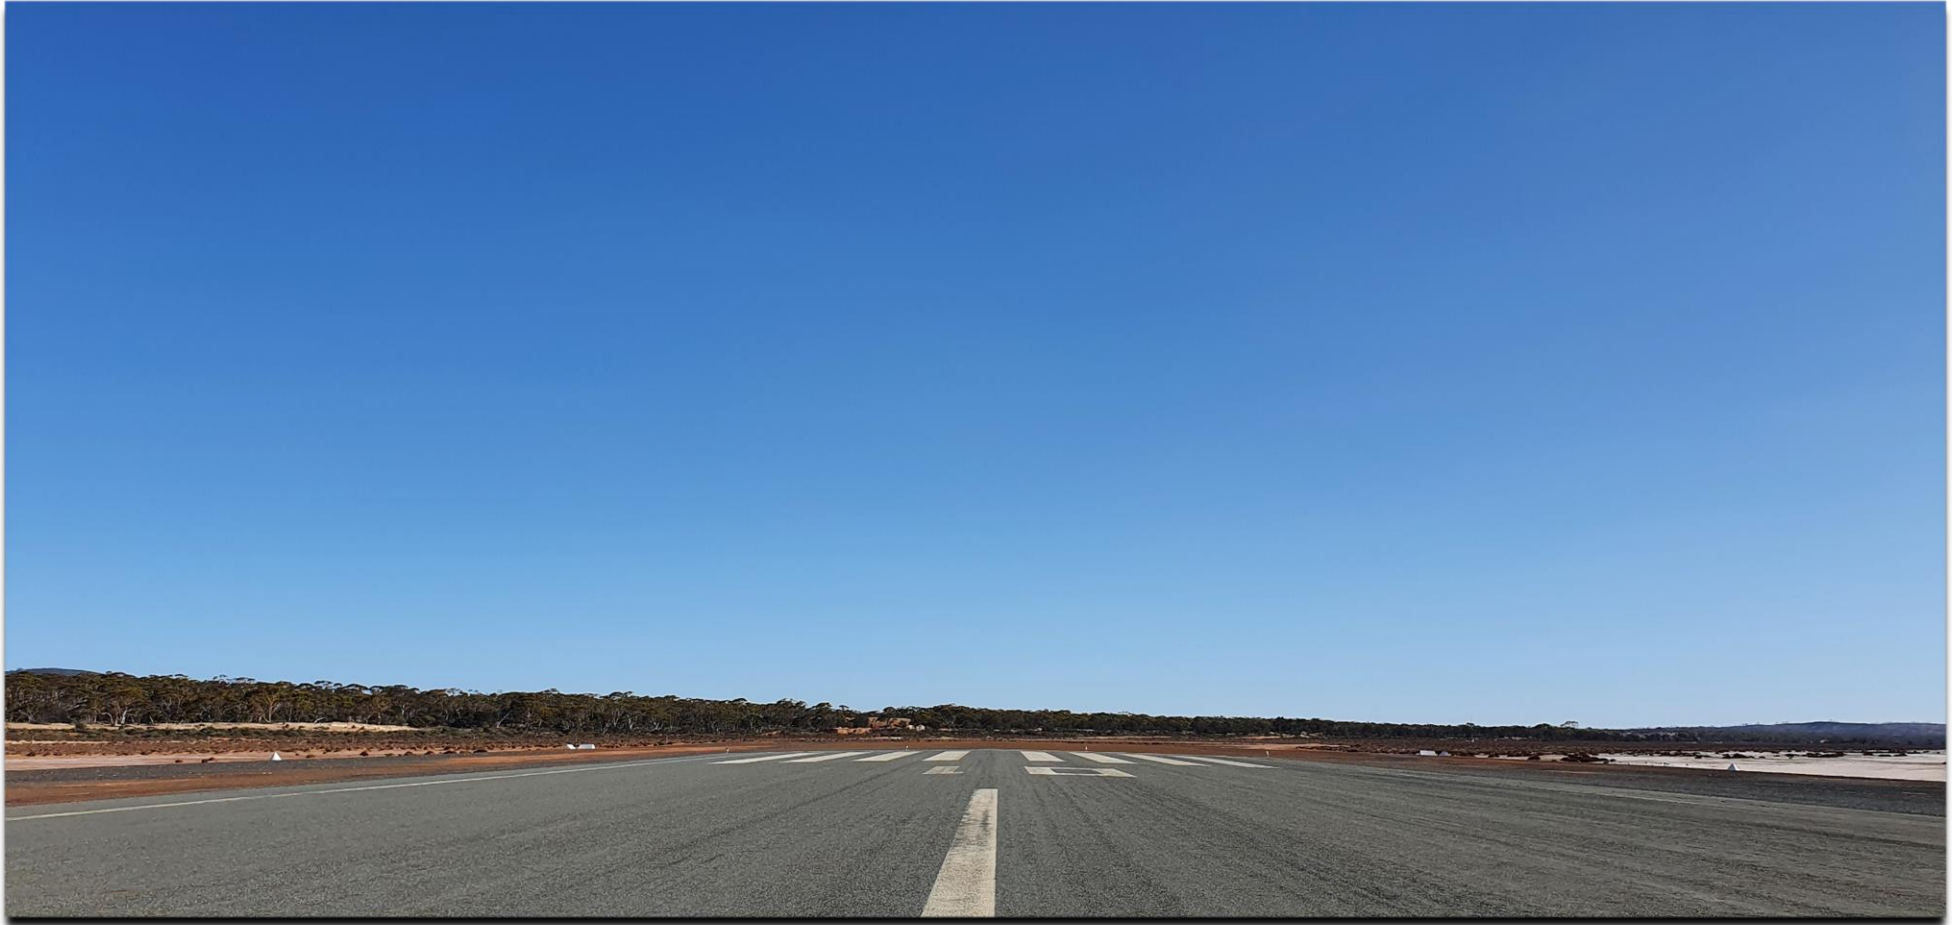
Runway 19 Take-off

19	3	Tree	405.93 m	19.29 m	4.75%	283.32 m	1884.93 m	242.79 mL	Outside TKOF SFC		
19	4	Tree	353.94 m	14.12 m	3.99%	278.15 m	1832.94 m	212.82 mL	Outside TKOF SFC		
19	5	Tree	415.44 m	15.96 m	3.84%	279.98 m	1894.44 m	178.07 mL	Outside TKOF SFC		
19	6	Tree	910.44 m	20.77 m	2.28%	284.79 m	2389.44 m	31.8 mL	Critical Object		
19	7	Weather Station	403.56 m	8.2 m	2.03%	272.23 m	1882.56 m	162.36 mR	Outside TKOF SFC
